Manhole Inspection Summary

Manhole # S03WW1017MH

Insp Date: **8/15/06 12:00 AM**

Location Address: **3514 MENLO DR**

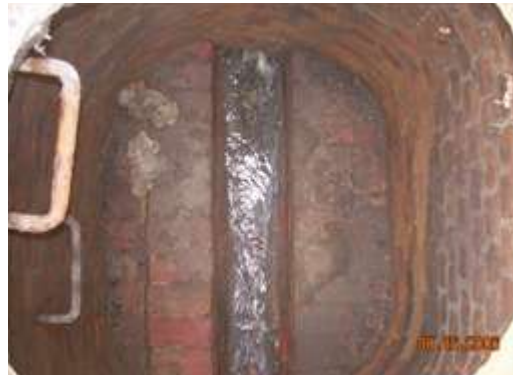
Top View

Comments **Top View picture indicates evidence of infiltration through the corbel and the barrel walls.**

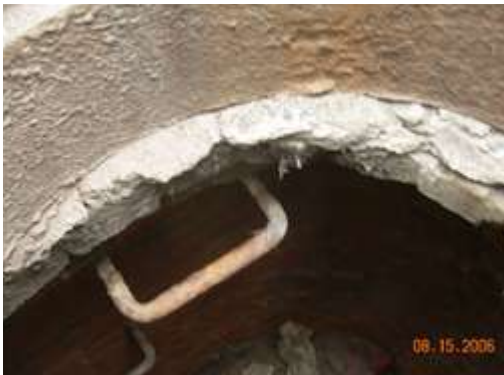
Defect

Frame leaks. Adjustment loose brick.
Adjustment, Corbel, and Barrel infiltration.
Corroded steps. Bench debris.

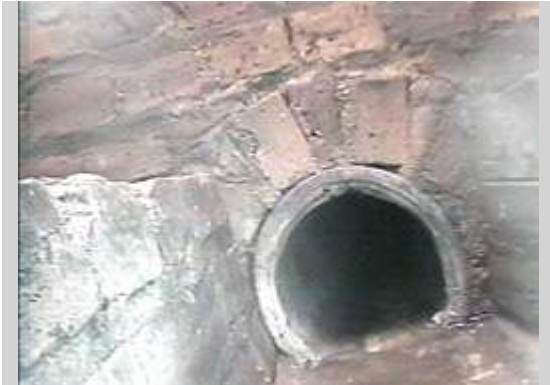
8 in. Circular Gravity Sewer Pipe Out @ 12 O'Clock

Infiltration: **Evidence** Pipe Seal Cond: **Unknown**

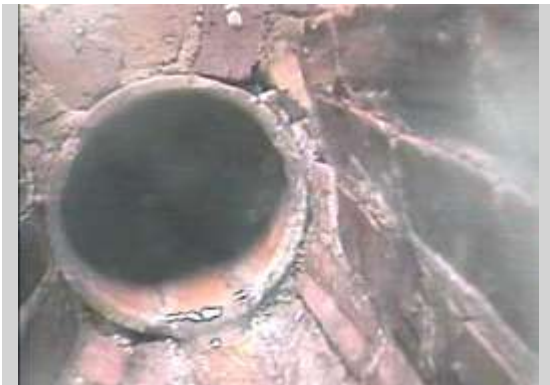
8 in. Circular Gravity Sewer Pipe In @ 6 O'Clock

Infiltration: **Evidence** Pipe Seal Cond: **Broken**
